R08-15 Photoluminescence of Polished and Etched Semi-Insulating CdTe:In

J. Zázvorka, J. Franc, P. Hlíděk

Charles University in Prague, Faculty of Mathematics and Physics, Institute of Physics, Ke Karlovu 5, CZ-121 16, Prague 2, Czech Republic

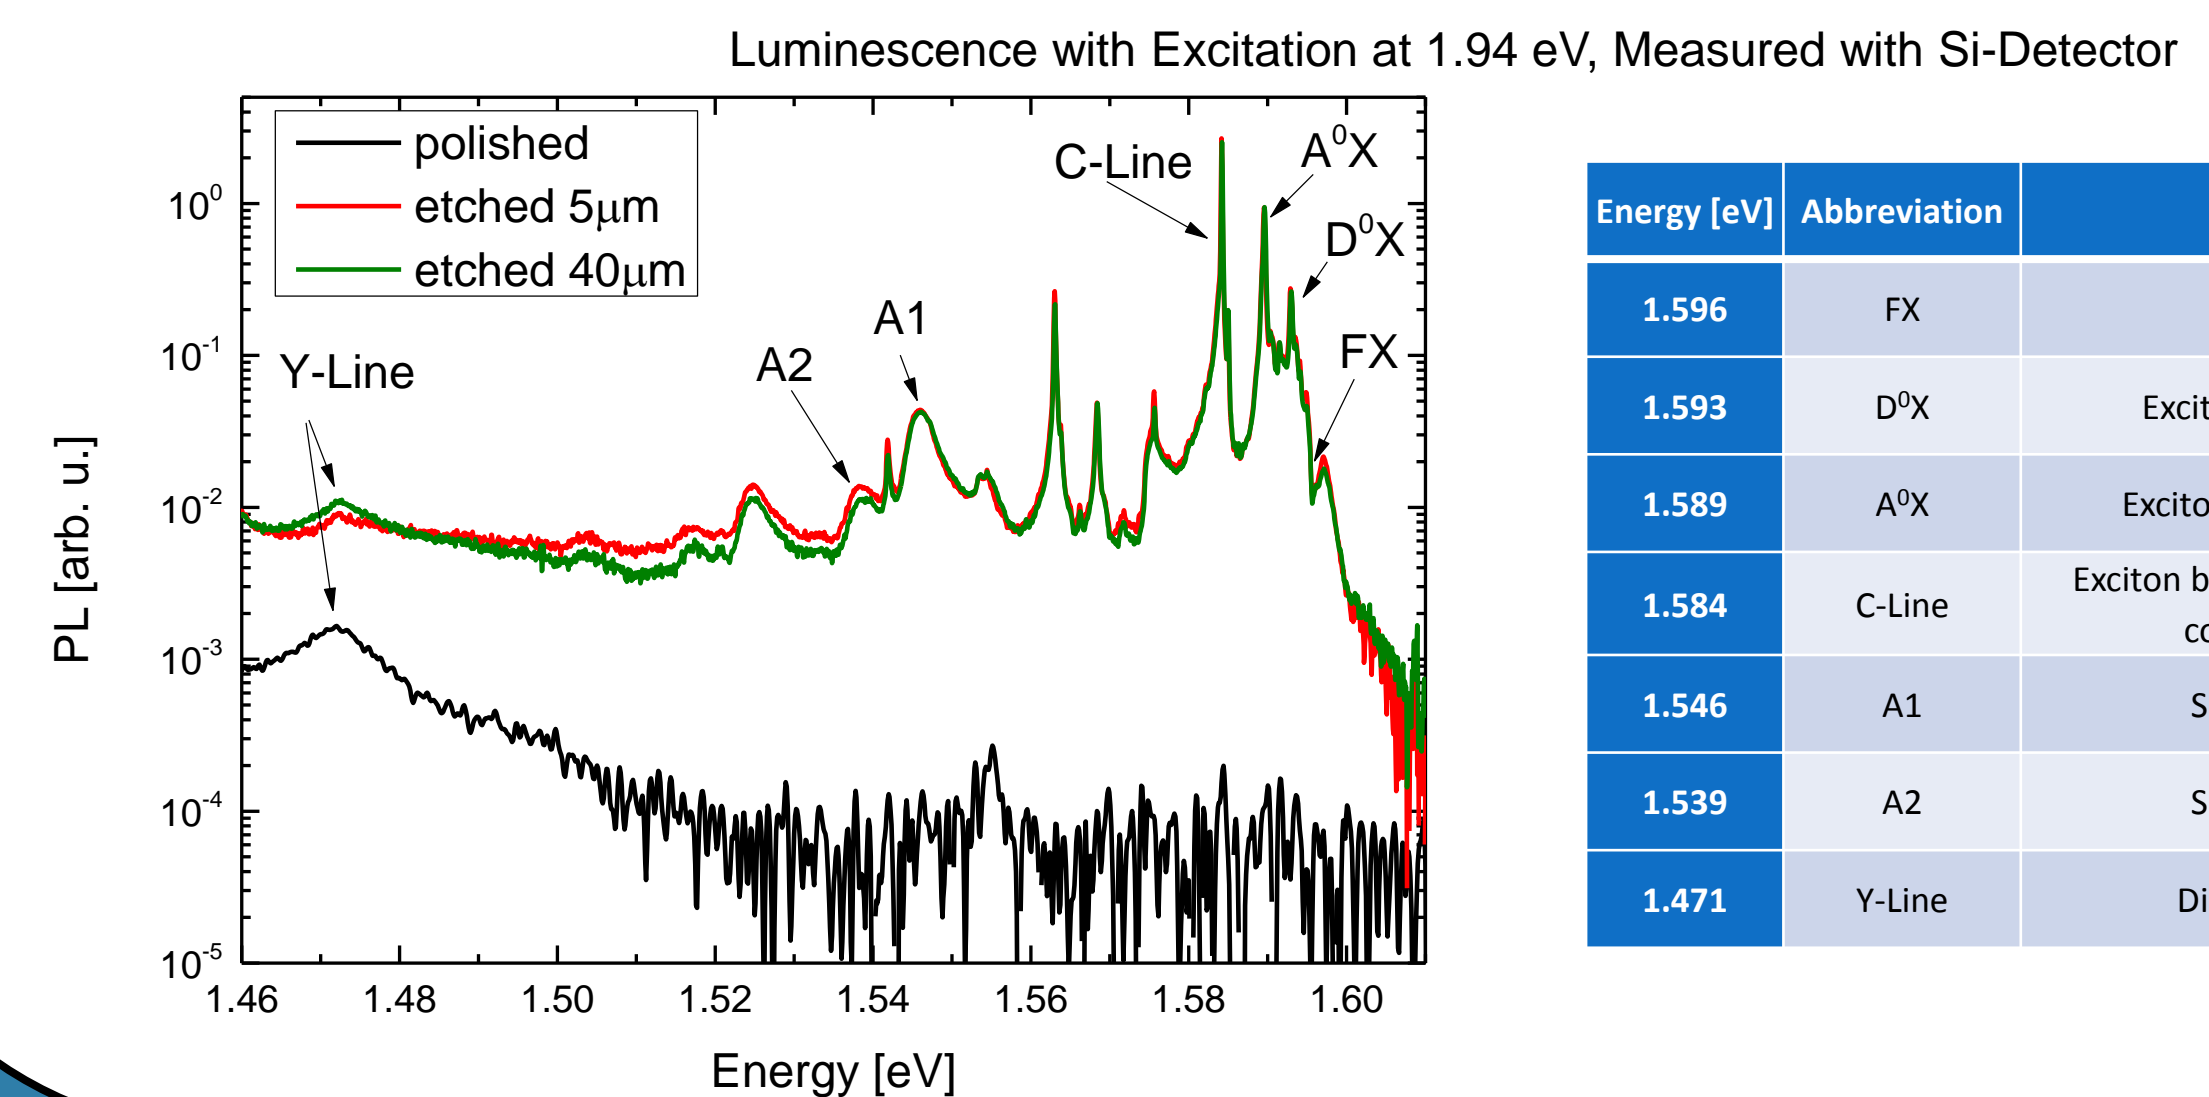
- CdTe doped with indium, detector grade material
- Polished with 1μm abrasive, surface RMS ≈1.5nm (measured with white-light Zygo interferometer)
- 4 treatments of chemical etching in 1% Br-MeOH solution
- Surface amount etched measured relative to polished surface (5μm, 10 μm, 15 μm, 40μm – from both sides, respectively)
- Polished surface => no near bandgap luminescence, just Y-Line (in literature connected to dislocation defects)
- Etched surface => exciton luminescence visible, Y-Line

Energy [eV]	Abbreviation	Type
1.596	FX	Free exciton
1.593	D ⁰ X	Exciton bound to donor
1.589	A ⁰ X	Exciton bound to acceptor
1.584	C-Line	Exciton bound to complex defect containing indium
1.546	A1	Shallow acceptor
1.539	A2	Shallow acceptor
1.471	Y-Line	Dislocation defects

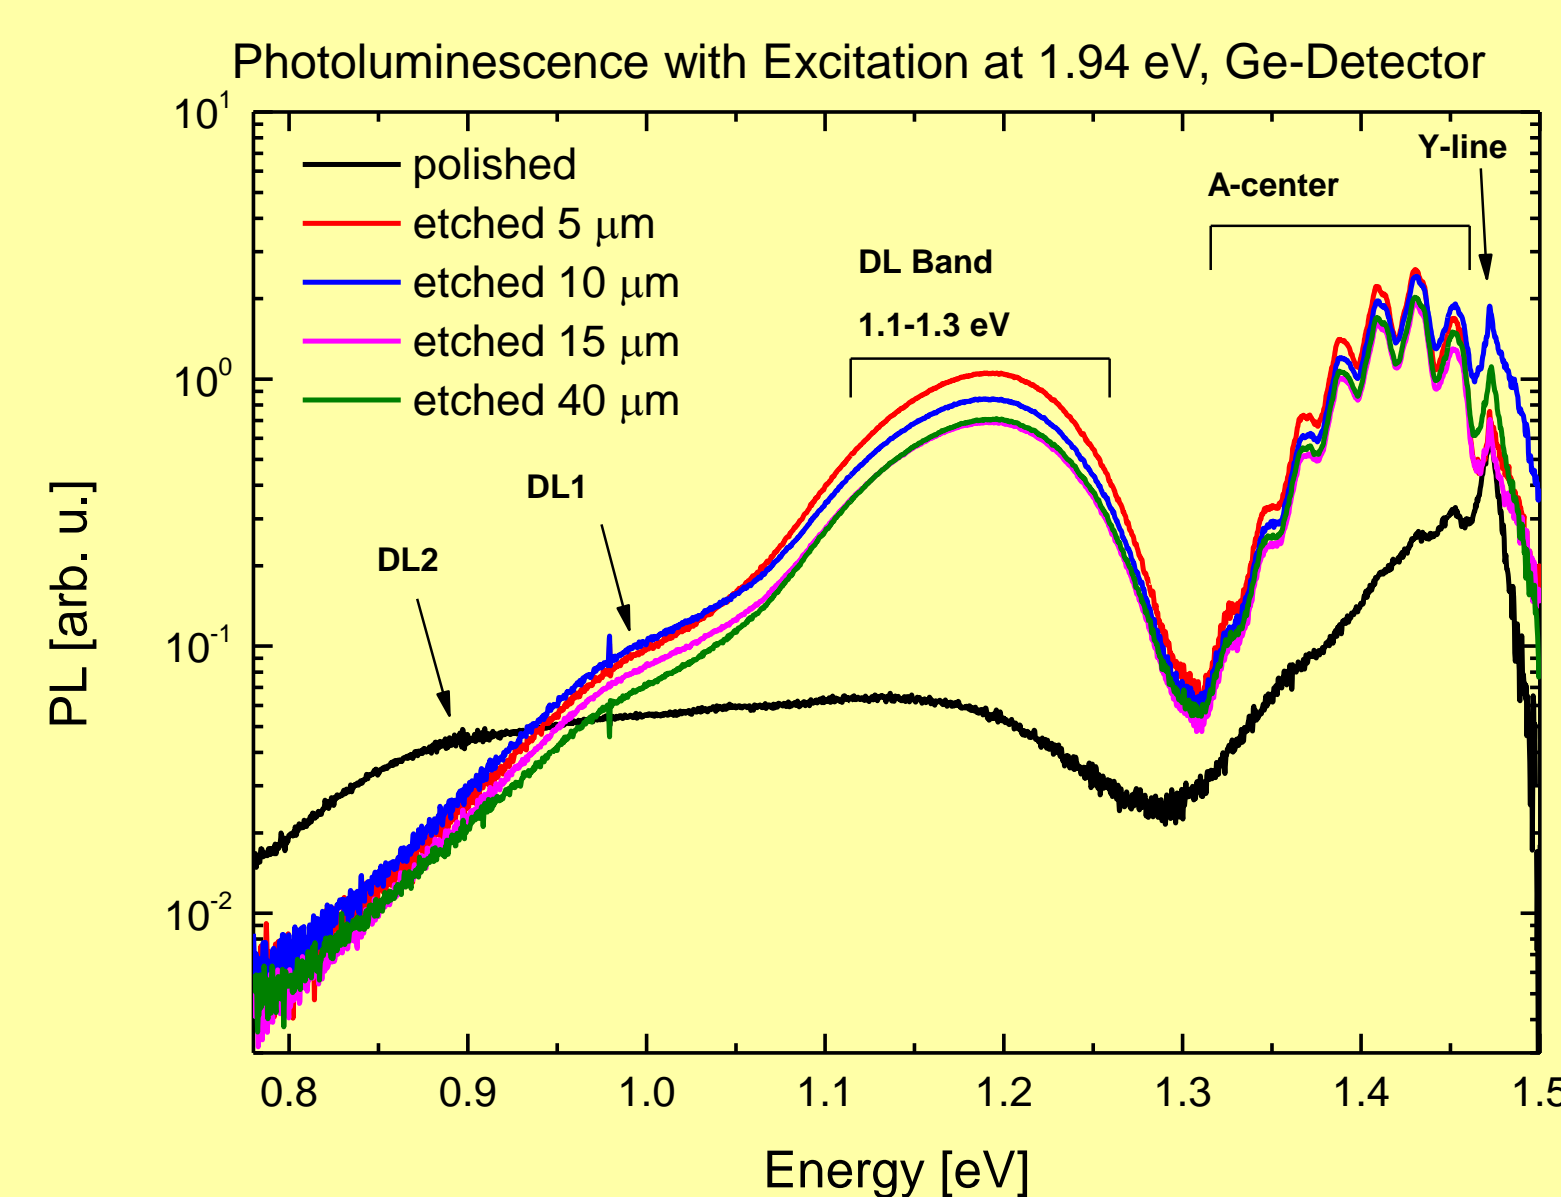
Further Investigation of Deep Levels

Deep levels found:

- 1.30 – 1.46 eV : A-Center
- 1.10 – 1.30 eV : Deep level band (DL-Band)
- 1.05 eV : Deep level 1 (DL1)
- 0.92 eV : Deep level 2 (DL2)
- 0.67 eV : Deep level 3 (DL3)
- InSb detector used

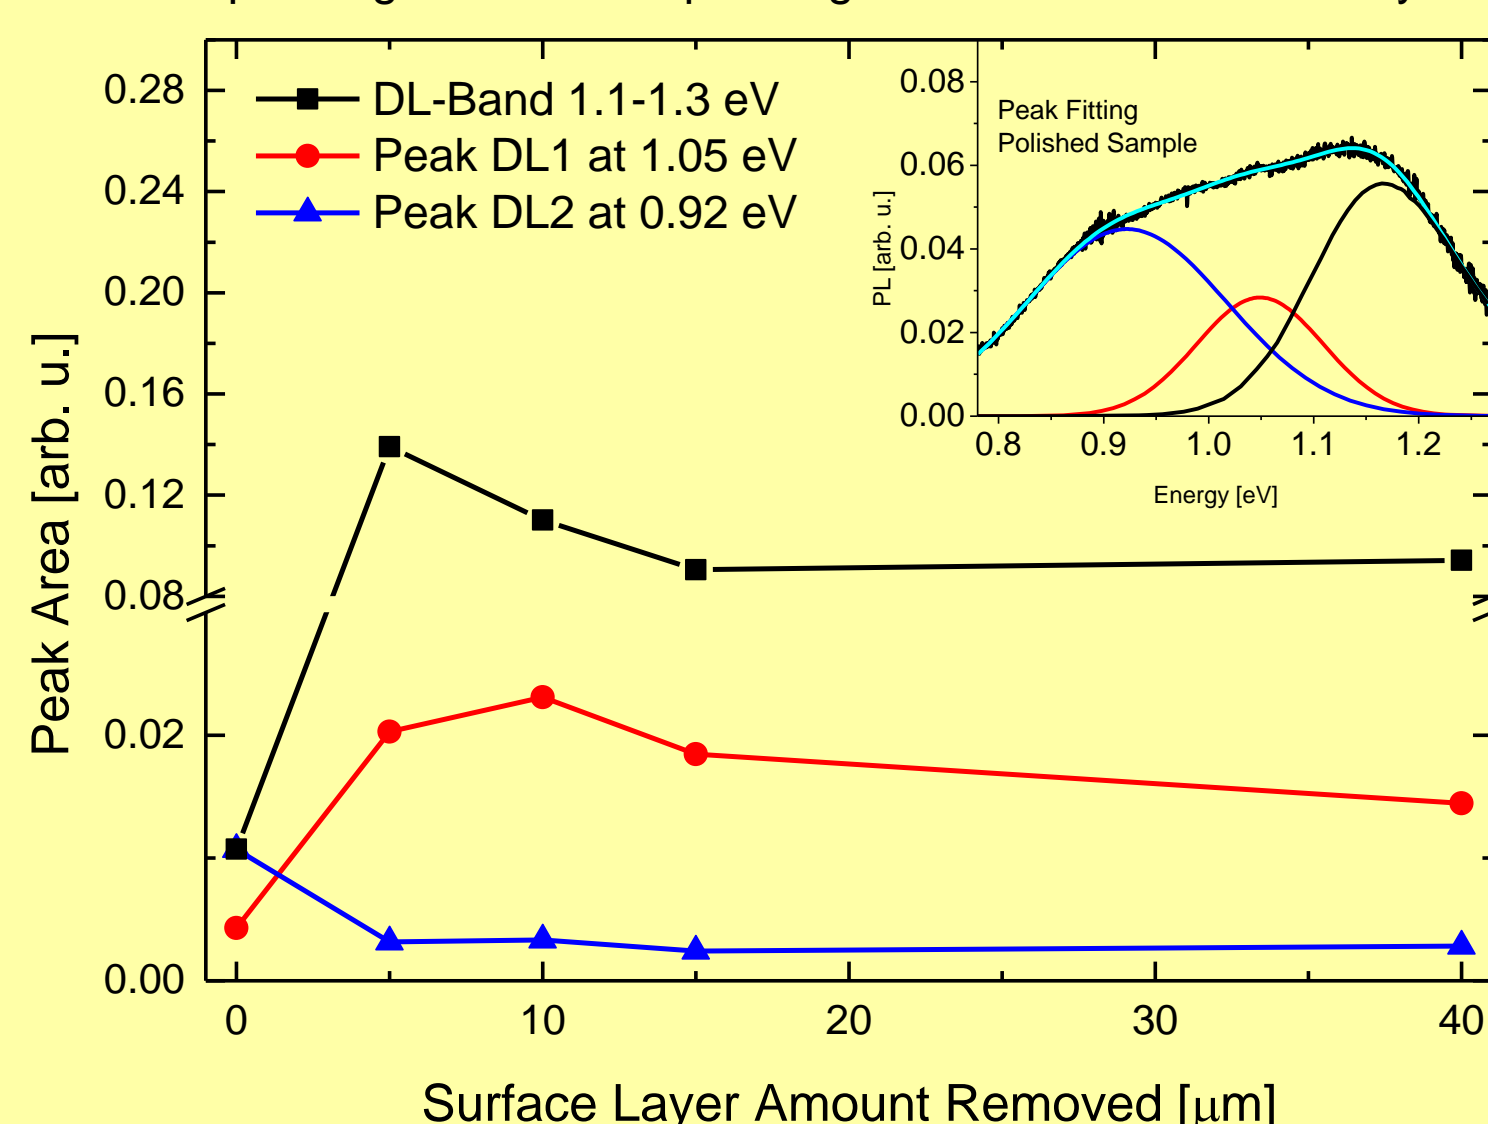
Peak Area Depending Evolution Depending on Amount of Surface Layer Etched

Fitted Peaks Analysis

- DL3 remains constant during sample etching
- After slight etching DL2 diminished rapidly
- Photoluminescence of DL and DL-band increases with etching and saturizes
- DL2 is linked to surface damaged layer defects
- Y-Line and DL2 are connected to sample surface, but are independent on each other

- Y-Line (dislocation defect) is independent on sample surface preparation (up to 40 μm)
- A deep level DL2 at 0.92 eV connected to sample surface was found
- Photoluminescence of DL2 diminishes rapidly after etching of 5 μm of the sample
 - Upon polishing photoluminescence of deep level DL2 can be more visible

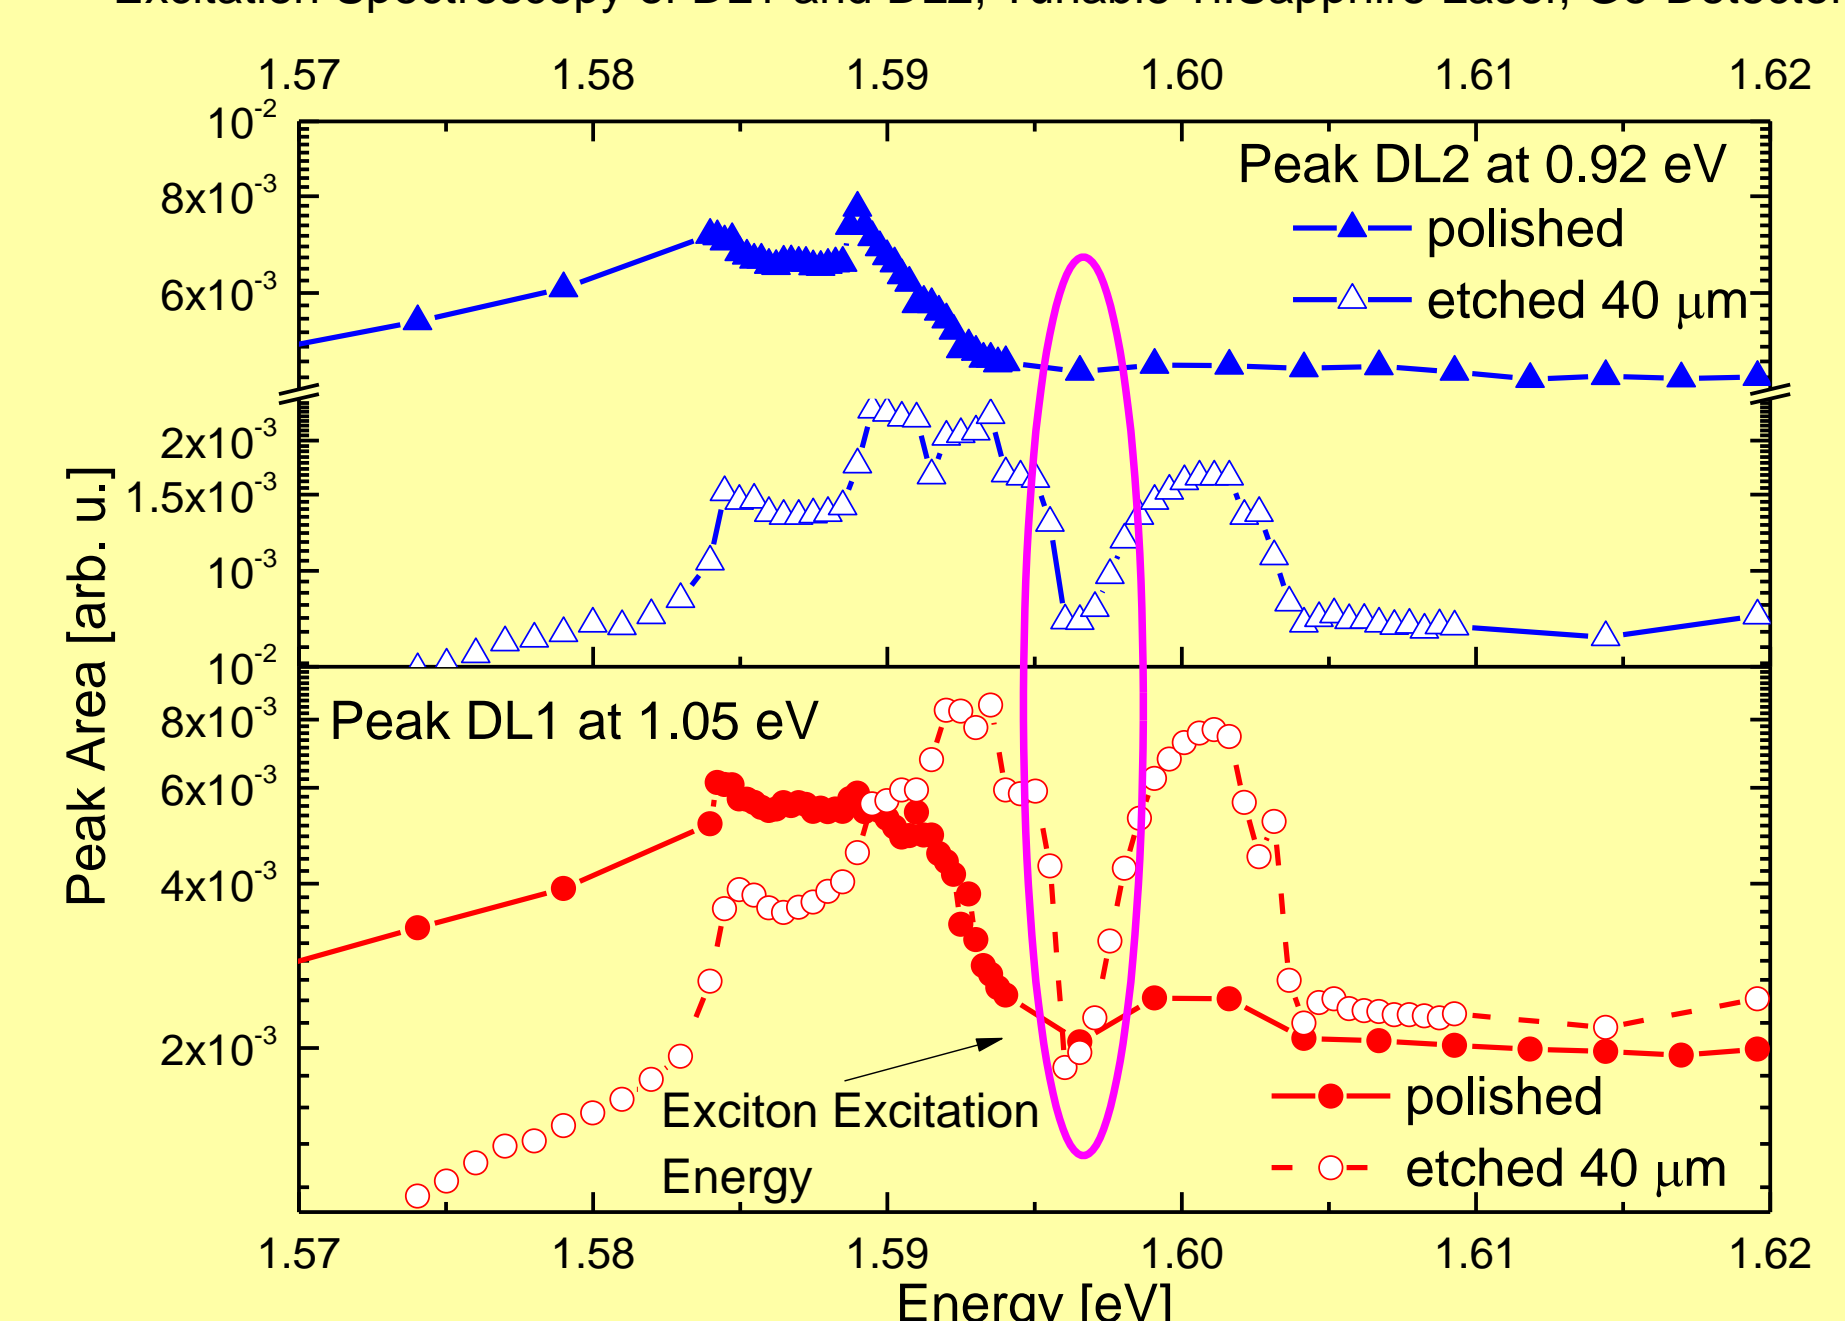
Excitation Spectroscopy of DL1 and DL2, Tunable Ti:Sapphire Laser, Ge-Detector

- Excitation with tunable Ti:Sapphire laser
- DL1 and DL2 investigation
- Free exciton dip related to crystal lattice quality
- Polished surface:
 - No free exciton dip of DL2
- Etched surface:
 - Photoluminescence increase in exciton excitation region for DL1 and DL2

⇒ DL2 is more susceptible to damaged surface layer

- DL2 is located closer to sample surface
